Waterbody Data Sheet

Description			
Project Name: Line 5 Relocation Project		Date: 2019-09-06	Waterbody Survey ID: sasa004p
State: WI	County/Parish: Ashland	USGS Waterbody Name: UNT to Gehrman Creek	
Company: Enbridge	Crew Member Initials: NTT/DGL	Latitude: 46.365579	Longitude: -90.588129
Survey Type: <input checked="" type="checkbox"/> Centerline <input type="checkbox"/> Re-Route <input type="checkbox"/> Access Road <input type="checkbox"/> Facility <input type="checkbox"/> Other <small>(check one)</small>			
Waterbody Type: <input type="checkbox"/> River <input checked="" type="checkbox"/> Stream <input type="checkbox"/> Ditch <input type="checkbox"/> Swale <input type="checkbox"/> Canal <input type="checkbox"/> Other <small>(check one)</small>			
Water Appearance: <input type="checkbox"/> No Water <input checked="" type="checkbox"/> Clear <input type="checkbox"/> Turbid <input type="checkbox"/> Sheen on Surface <input type="checkbox"/> Surface Scum <input type="checkbox"/> Algal Mats <input type="checkbox"/> Other <small>(check one)</small>

APPENDIX F

Waterbody Data Sheets

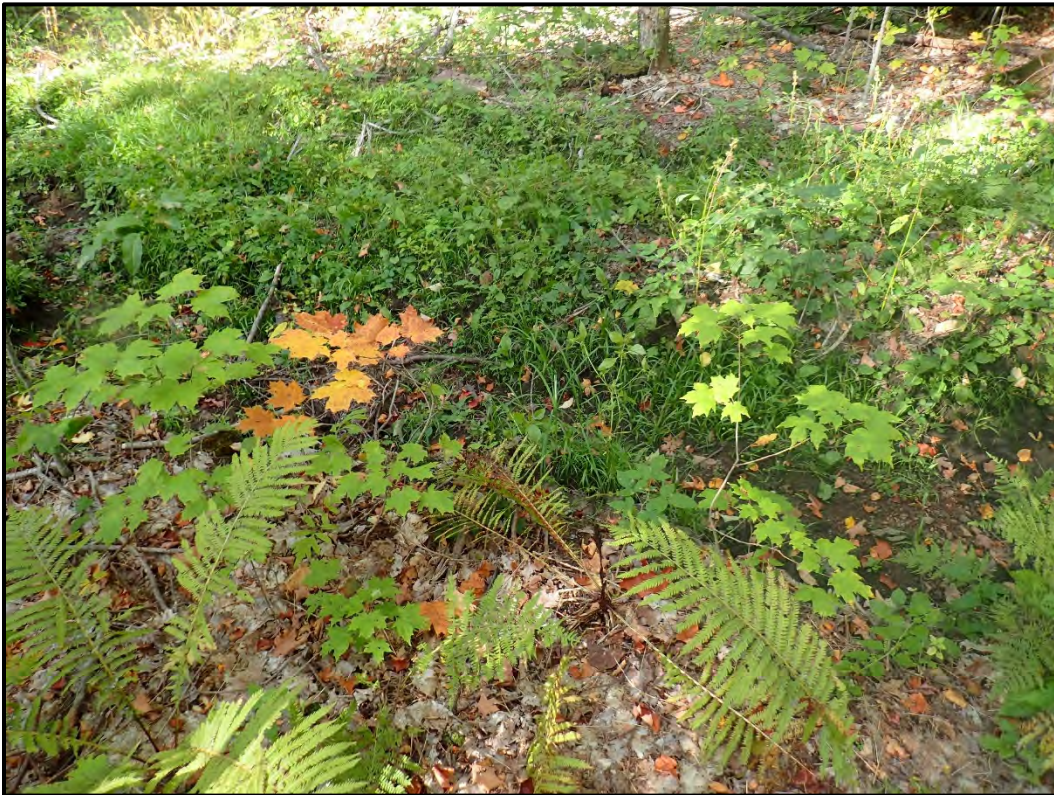
sirb007e_N (across)

Vegetation Layers: <input checked="" type="checkbox"/> Trees <input checked="" type="checkbox"/> Saplings/Shrubs <input checked="" type="checkbox"/> Herbs <small>(check all that apply)</small>			
Dominant Bank Vegetation (list): The swale runs through a mesic hardwood forest.			
Aquatic Habitats (ex: submerged or emerged aquatic vegetation, overhanging banks/roots, leaf packs, large submerged wood, riffles, deep pools, etc.): None.			
Aquatic Organisms Observed (list): None.			
Disturbances (ex: livestock access, manure in waterbody, waste discharge pipes): The banks of the feature are eroded, exposing shrub roots.			
Observation Notes: The swale runs adjacent to an access road. There is no water present at the time of survey.

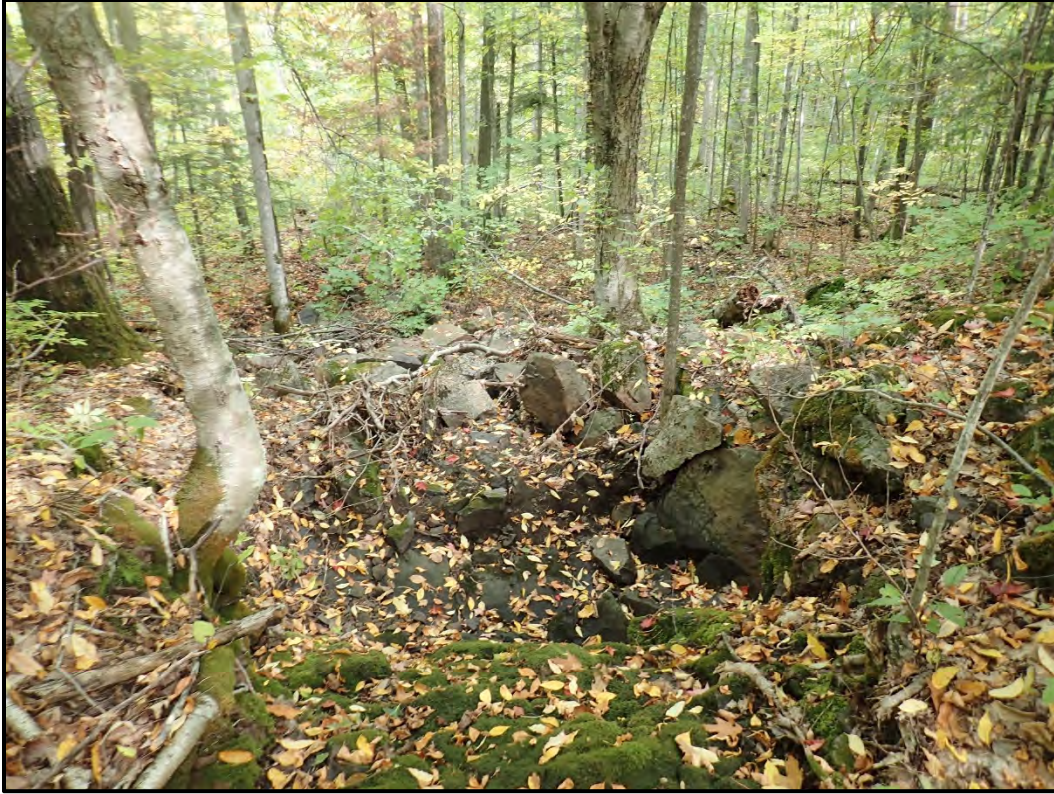
sirb001e_N (downstream)

Vegetation Layers: <input checked="" type="checkbox"/> Trees <input type="checkbox"/> Saplings/Shrubs <input type="checkbox"/> Herbs <i>(check all that apply)</i>			
Dominant Bank Vegetation (list): Betula alleghaniensis, Fraxinus pennsylvanica, and Ostrya virginiana.			
Aquatic Habitats (ex: submerged or emerged aquatic vegetation, overhanging banks/roots, leaf packs, large submerged wood, riffles, deep pools, etc.): None.			
Aquatic Organisms Observed (list): None.			
Disturbances (ex: livestock access, manure in waterbody, waste discharge pipes): None.			
Observation Notes: The feature is an ephemeral stream flowing through woodland. There is no water present at the time of survey.

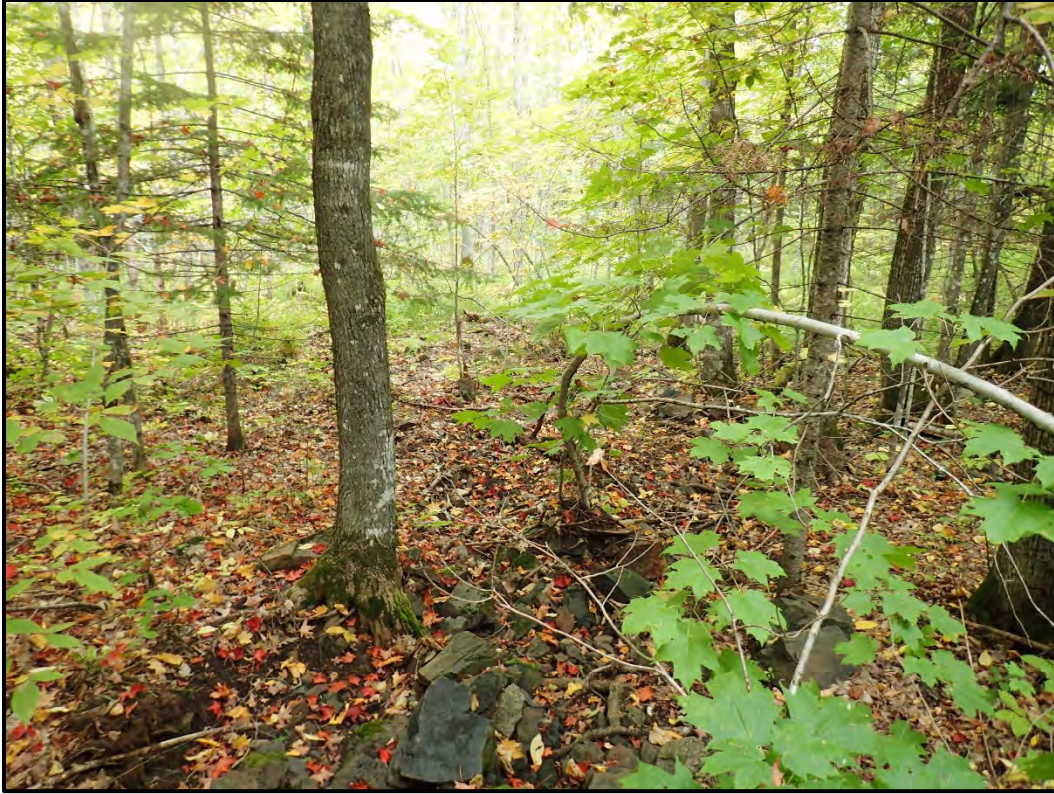
sirb002e_N (downstream)

Vegetation Layers: <input checked="" type="checkbox"/> Trees <input type="checkbox"/> Saplings/Shrubs <input checked="" type="checkbox"/> Herbs <small>(check all that apply)</small>			
Dominant Bank Vegetation (list): Fraxinus pennsylvanica, Athyrium filix-femina.			
Aquatic Habitats (ex: submerged or emerged aquatic vegetation, overhanging banks/roots, leaf packs, large submerged wood, riffles, deep pools, etc.): None.			
Aquatic Organisms Observed (list): None.			
Disturbances (ex: livestock access, manure in waterbody, waste discharge pipes): None.			
Observation Notes: The waterbody branches off of feature sirb001e.

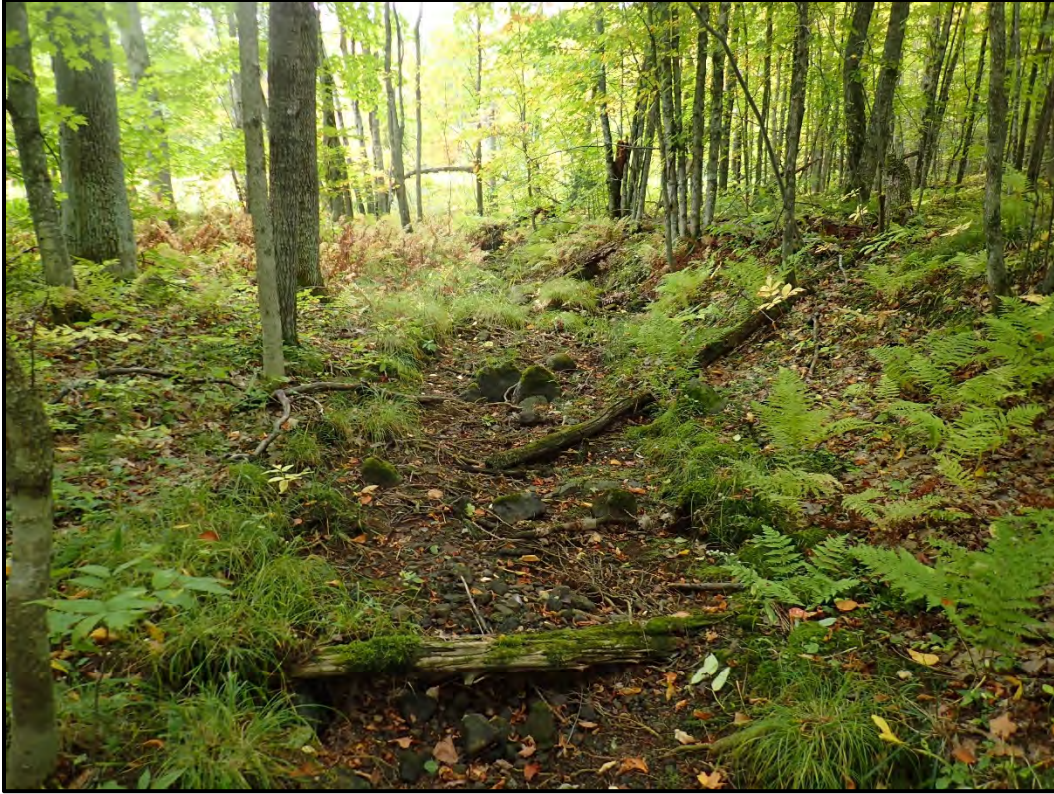
sirb003e_E (downstream)

Observations			
Riparian Zone Present: <input type="checkbox"/> Yes <input checked="" type="checkbox"/> No <small>(check one)</small>			
Vegetation Layers: <input checked="" type="checkbox"/> Trees <input checked="" type="checkbox"/> Saplings/Shrubs <input checked="" type="checkbox"/> Herbs <small>(check all that apply)</small>			
Dominant Bank Vegetation (list): The feature is surrounded by mesic hardwood forest.			
Aquatic Habitats (ex: submerged or emerged aquatic vegetation, overhanging banks/roots, leaf packs, large submerged wood, riffles, deep pools, etc.): None.			
Aquatic Organisms Observed (list): None.			
Disturbances (ex: livestock access, manure in waterbody, waste discharge pipes): The feature is disturbed by erosion at the banks.			
Observation Notes: The feature runs from upland mesic hardwood into disturbed fresh wet meadow. There is currently no water in the feature.

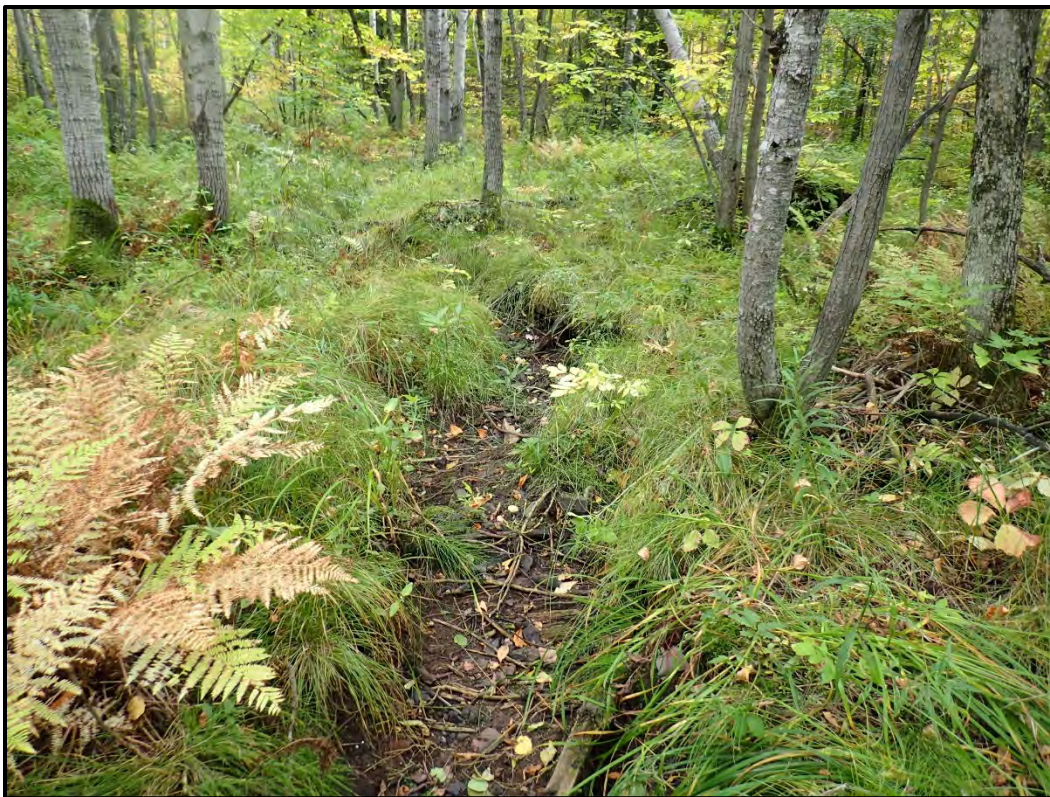
sirb004e_E (upstream)

Vegetation Layers: <input checked="" type="checkbox"/> Trees <input type="checkbox"/> Saplings/Shrubs <input checked="" type="checkbox"/> Herbs <small>(check all that apply)</small>			
Dominant Bank Vegetation (list): Fraxinus nigra, Ulmus americana, Acer saccharum, Carex radiata, Athyrium filix-femina.			
Aquatic Habitats (ex: submerged or emerged aquatic vegetation, overhanging banks/roots, leaf packs, large submerged wood, riffles, deep pools, etc.): None.			
Aquatic Organisms Observed (list): None.			
Disturbances (ex: livestock access, manure in waterbody, waste discharge pipes): None.			
Observation Notes: The feature does not contain water at the time of survey.

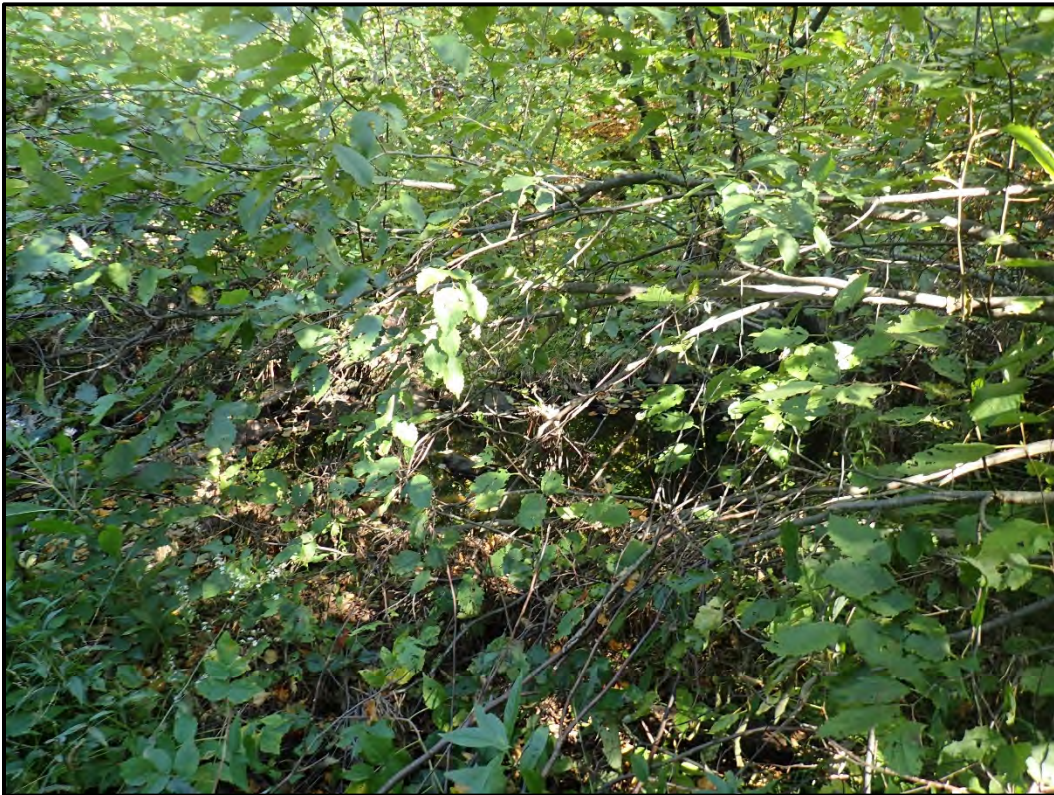
sirb005p_N (across)

Observations			
Riparian Zone Present: <input checked="" type="checkbox"/> Yes <input type="checkbox"/> No <small>(check one)</small>			
Vegetation Layers: <input type="checkbox"/> Trees <input checked="" type="checkbox"/> Saplings/Shrubs <input checked="" type="checkbox"/> Herbs <small>(check all that apply)</small>			
Dominant Bank Vegetation (list): The banks of the stream have similar species composition to the connected wetland feature including Alnus incana, Scirpus cyperinus, Scirpus atrovirens, Agrostis gigantea, and Solidago canadensis.			
Aquatic Habitats (ex: submerged or emerged aquatic vegetation, overhanging banks/roots, leaf packs, large submerged wood, riffles, deep pools, etc.): Standing water is present.			
Aquatic Organisms Observed (list): Common green darner, unknown fish sp., water striders, northern leopard frog.			
Disturbances (ex: livestock access, manure in waterbody, waste discharge pipes): There is moderate invasive species cover within close proximity of the waterbody. The feature is modified by beaver activity.

Observation Notes: The feature runs roughly N-S before dissipating into wetland wirb015. The feature is also associated with a beaver impoundment.

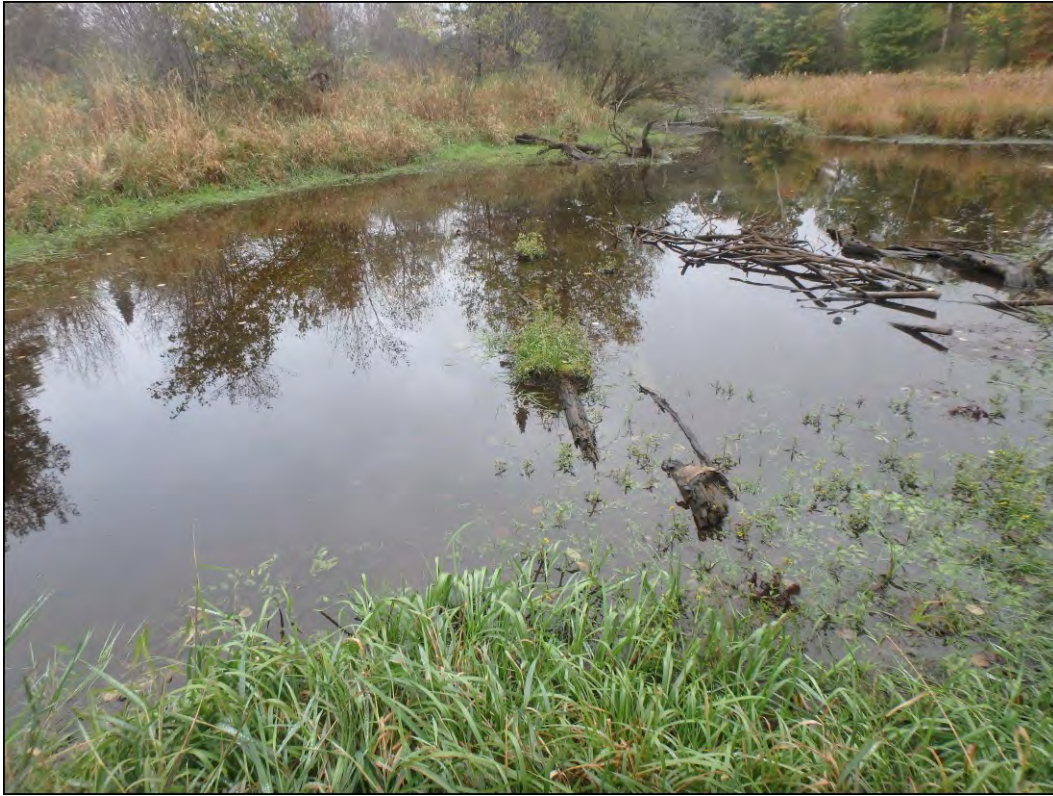
oase001_E

Disturbances (ex: livestock access, manure in waterbody, waste discharge pipes): Runoff from adjacent road.			
Observation Notes: Feature continues outside survey corridor.

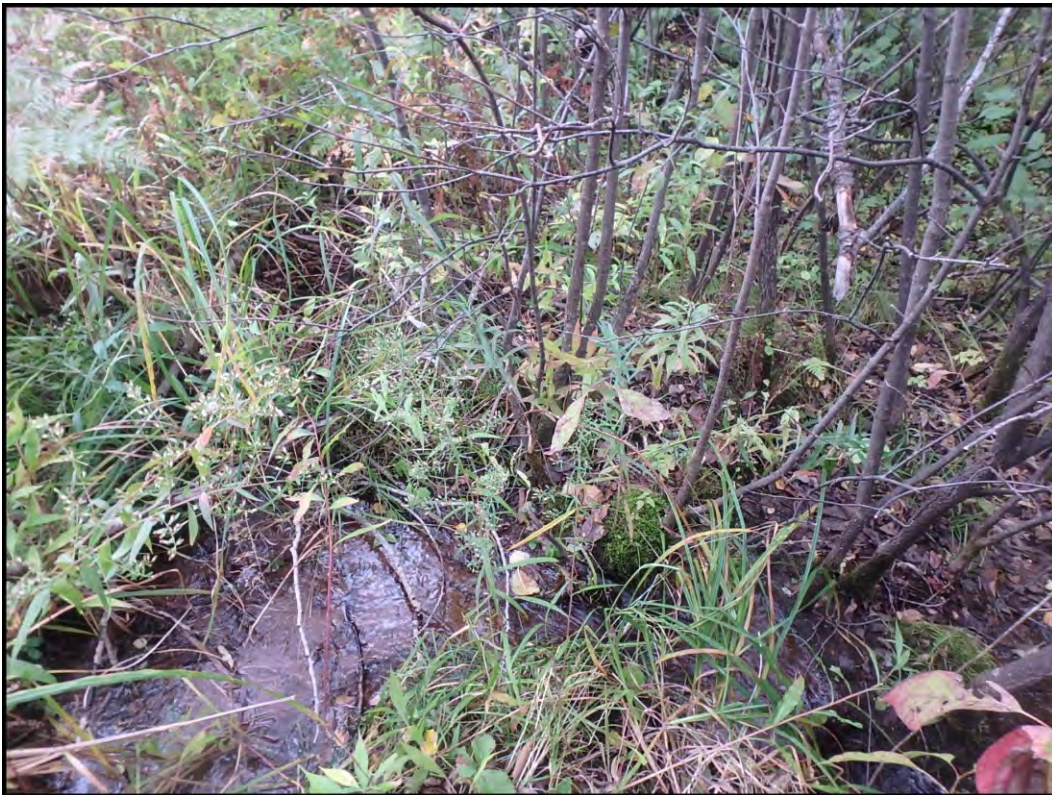
sasc031i_S (across)

Vegetation Layers: <input checked="" type="checkbox"/> Trees <input checked="" type="checkbox"/> Saplings/Shrubs <input checked="" type="checkbox"/> Herbs <i>(check all that apply)</i>			
Dominant Bank Vegetation (list): Populus tremuloides, Alnus incana, Glyceria striata, Carex crinita, Symphyotrichum lateriflorum.			
Aquatic Habitats (ex: submerged or emerged aquatic vegetation, overhanging banks/roots, leaf packs, large submerged wood, riffles, deep pools, etc.): Overhanging vegetation.			
Aquatic Organisms Observed (list): None.			
Disturbances (ex: livestock access, manure in waterbody, waste discharge pipes): Runoff from dirt road.			
Observation Notes: The stream has been somewhat affected by the dirt road.

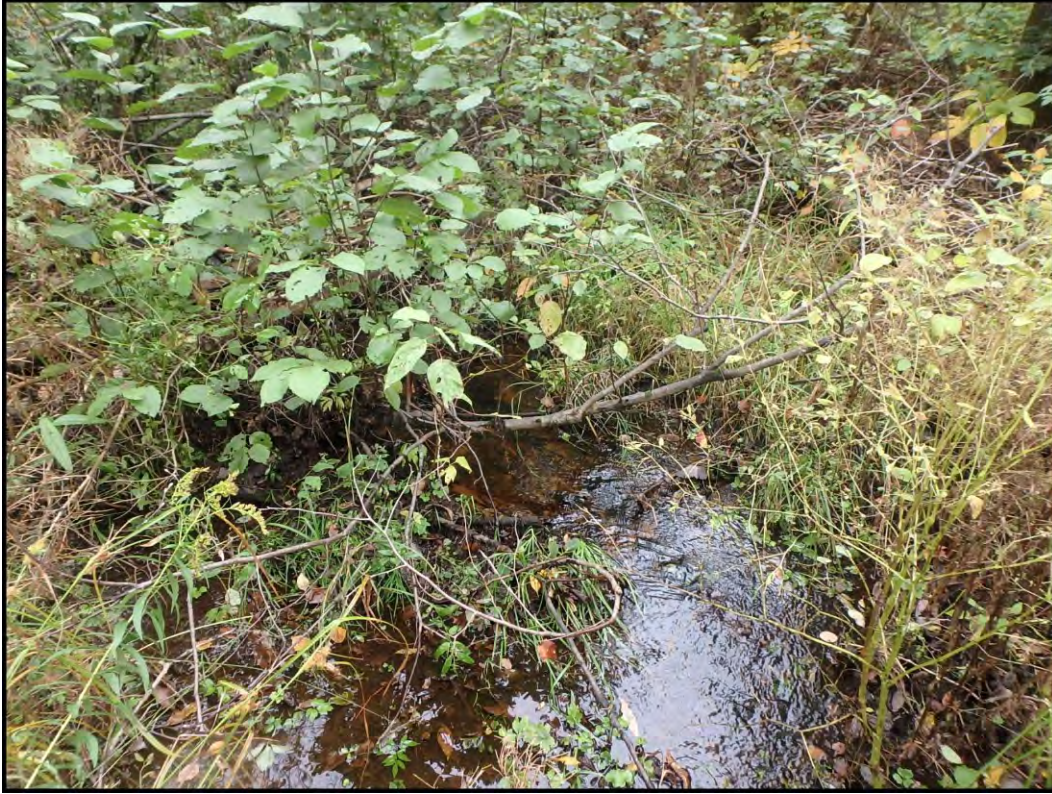
sasc030i_E (upstream)

Observations			
Riparian Zone Present: <input type="checkbox"/> Yes <input checked="" type="checkbox"/> No <small>(check one)</small>			
Vegetation Layers: <input checked="" type="checkbox"/> Trees <input checked="" type="checkbox"/> Saplings/Shrubs <input checked="" type="checkbox"/> Herbs <small>(check all that apply)</small>			
Dominant Bank Vegetation (list): Acer rubrum, Populus tremuloides, Alnus incana, Cornus sericea, Carex crinita, Impatiens capensis, Glyceria grandis, Carex retrorsa.			
Aquatic Habitats (ex: submerged or emerged aquatic vegetation, overhanging banks/roots, leaf packs, large submerged wood, riffles, deep pools, etc.): Riffles, overhanging vegetation.			
Aquatic Organisms Observed (list): None.			
Disturbances (ex: livestock access, manure in waterbody, waste discharge pipes): Runoff from dirt road, culvert, downstream beaver dam, historic logging activity.			
Observation Notes: The feature is somewhat disrupted by historic logging activity and road runoff, and is associated with alder thicket wetland wasc045s.

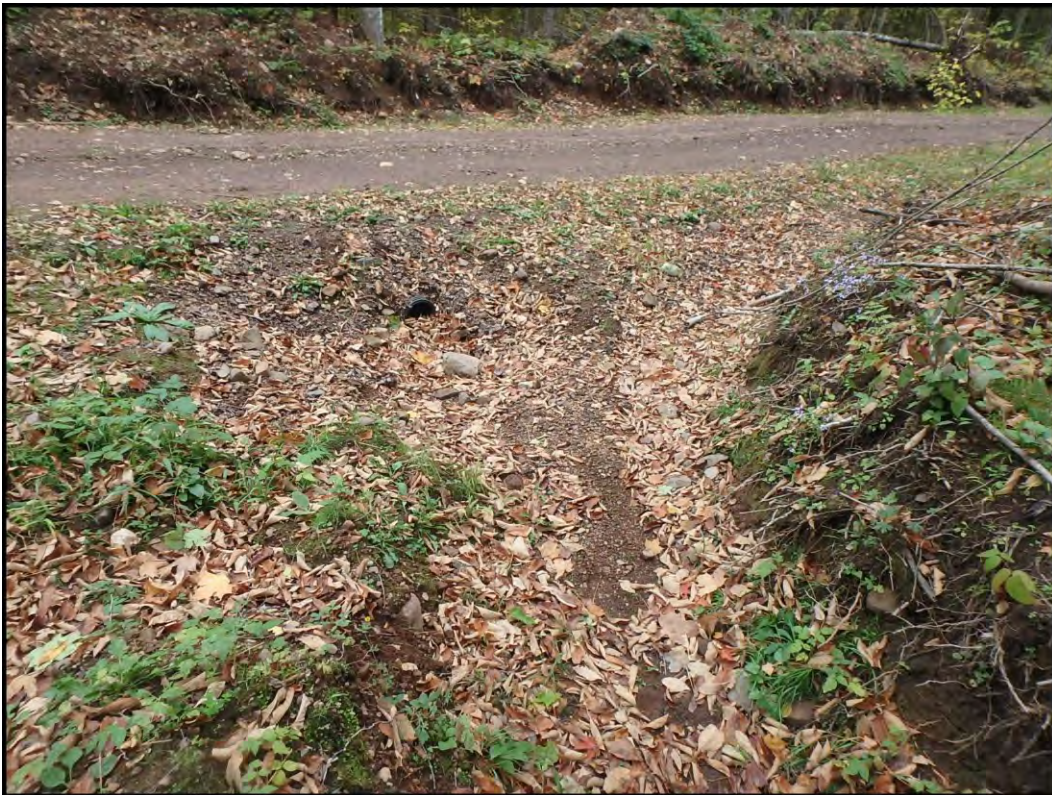
sirc006e_SE (downstream)

Existing Condition^a: <input type="checkbox"/> Highly Functional Stream <input type="checkbox"/> Moderately Functional Stream <input checked="" type="checkbox"/> Functionally Impaired Stream <small>(check one)</small>			
Feature Description: <input type="checkbox"/> Natural <input checked="" type="checkbox"/> Artificial, man-made <input type="checkbox"/> Manipulated <small>(check one)</small>			
Flow Regime: <input checked="" type="checkbox"/> Ephemeral <input type="checkbox"/> Intermittent <input type="checkbox"/> Perennial <input type="checkbox"/> Connecting Swale <small>(check one)</small>			
Sinuosity within Survey Corridor: <input type="checkbox"/> Straight <input checked="" type="checkbox"/> Meandering <small>(check one)</small>			
Description Notes: The feature is a small erosional stream that only exists as a result of runoff from the adjacent gravel road and associated culvert. It is a partially excavated artificial feature.

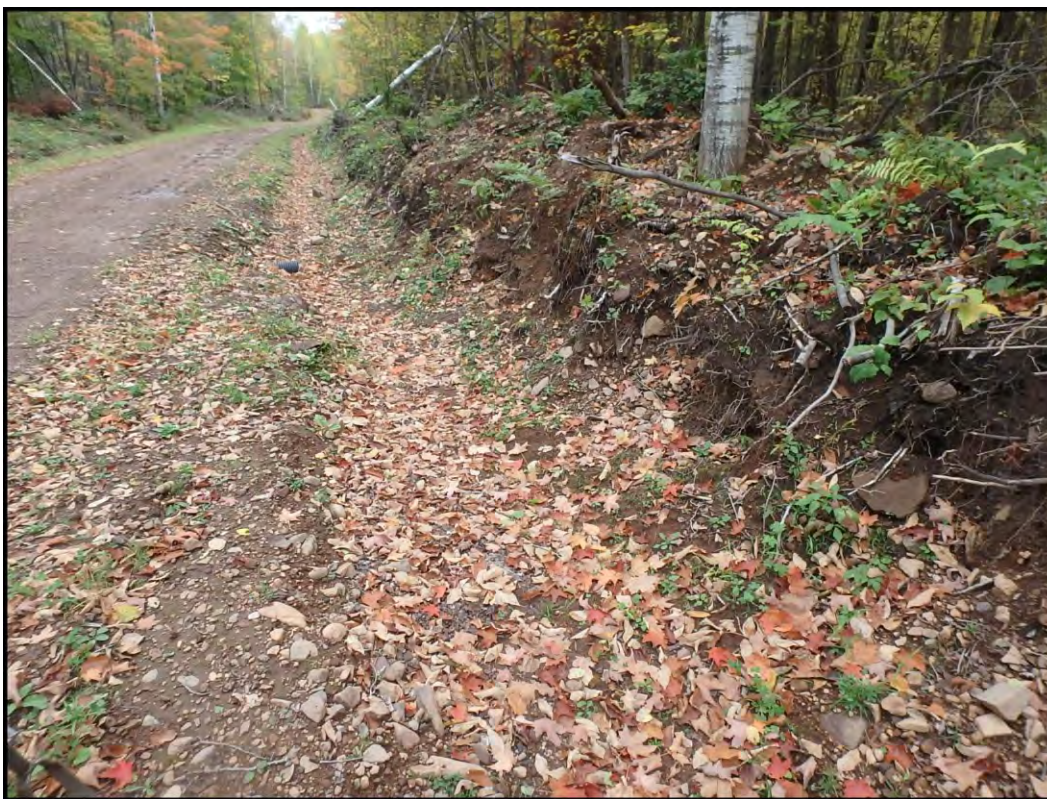
sirc008e_NE (downstream)

Vegetation Layers: <input checked="" type="checkbox"/> Trees <input checked="" type="checkbox"/> Saplings/Shrubs <input checked="" type="checkbox"/> Herbs <i>(check all that apply)</i>			
Dominant Bank Vegetation (list): Populus tremuloides, Acer saccharum, Rubus idaeus, Hypericum perforatum.			
Aquatic Habitats (ex: submerged or emerged aquatic vegetation, overhanging banks/roots, leaf packs, large submerged wood, riffles, deep pools, etc.): None.			
Aquatic Organisms Observed (list): None.			
Disturbances (ex: livestock access, manure in waterbody, waste discharge pipes): Runoff from gravel road.			
Observation Notes: The feature is associated with a culvert. Flows into sirc006e.

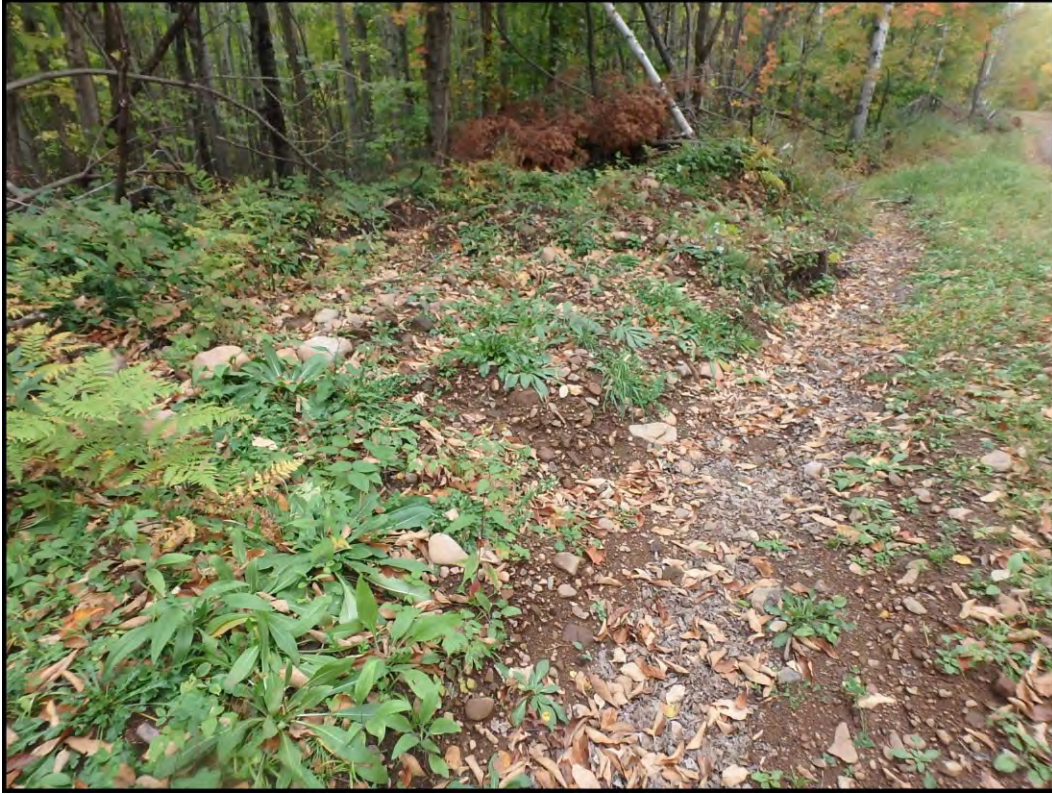
sirc007e_NE (upstream)

Vegetation Layers: <input type="checkbox"/> Trees <input type="checkbox"/> Saplings/Shrubs <input checked="" type="checkbox"/> Herbs <small>(check all that apply)</small>			
Dominant Bank Vegetation (list): Rubus idaeus, Oenothera biennis, Bidens frondosa, Hypericum perforatum, Persicaria sagittata, Scirpus hattorianus.			
Aquatic Habitats (ex: submerged or emerged aquatic vegetation, overhanging banks/roots, leaf packs, large submerged wood, riffles, deep pools, etc.): None.			
Aquatic Organisms Observed (list): None.			
Disturbances (ex: livestock access, manure in waterbody, waste discharge pipes): Runoff from gravel road.			
Observation Notes: The ditch feeds into ephemeral stream sirc006e.

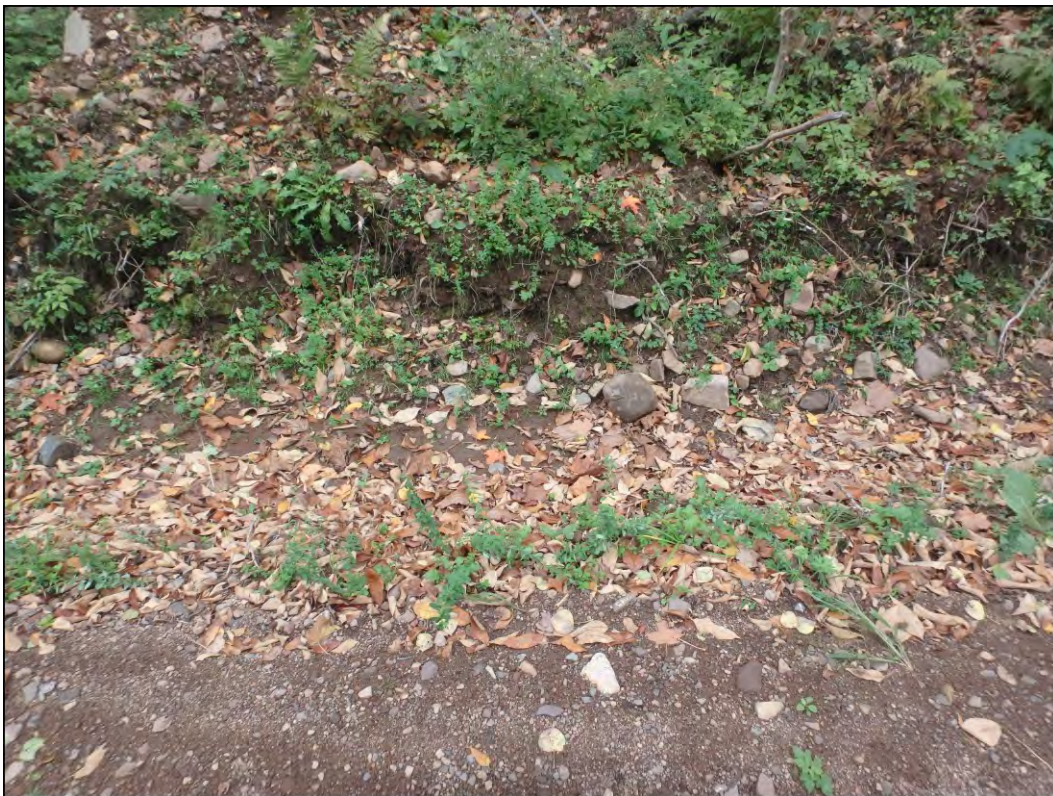
sire002e_SE (across)

Observations			
Riparian Zone Present: <input type="checkbox"/> Yes <input checked="" type="checkbox"/> No <small>(check one)</small>			
Vegetation Layers: <input type="checkbox"/> Trees <input type="checkbox"/> Saplings/Shrubs <input type="checkbox"/> Herbs <small>(check all that apply)</small>			
Dominant Bank Vegetation (list): No vegetation throughout ditch.			
Aquatic Habitats (ex: submerged or emerged aquatic vegetation, overhanging banks/roots, leaf packs, large submerged wood, riffles, deep pools, etc.): None.			
Aquatic Organisms Observed (list): None.			
Disturbances (ex: livestock access, manure in waterbody, waste discharge pipes): Recently excavated.			
Observation Notes: None.

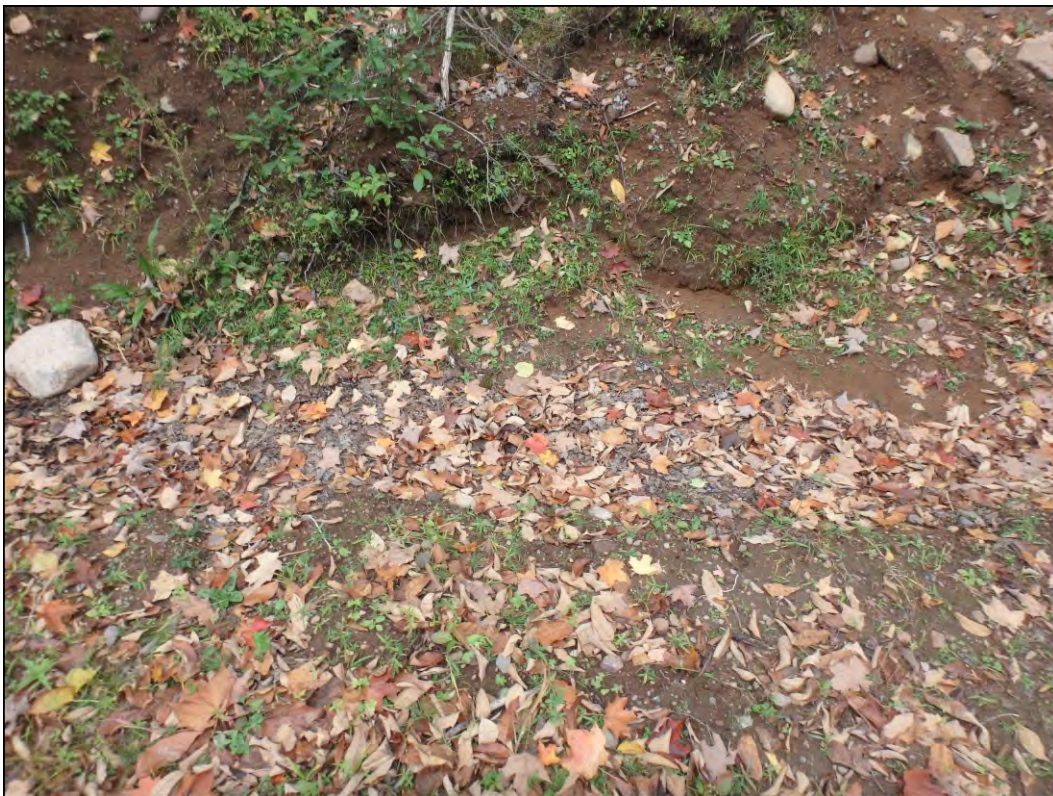
sire003e_SE (across)

Vegetation Layers: <input type="checkbox"/> Trees <input type="checkbox"/> Saplings/Shrubs <input type="checkbox"/> Herbs <i>(check all that apply)</i>			
Dominant Bank Vegetation (list): No vegetation present.			
Aquatic Habitats (ex: submerged or emerged aquatic vegetation, overhanging banks/roots, leaf packs, large submerged wood, riffles, deep pools, etc.): None.			
Aquatic Organisms Observed (list): None.			
Disturbances (ex: livestock access, manure in waterbody, waste discharge pipes): Waterbody was recently excavated.			
Observation Notes: None.

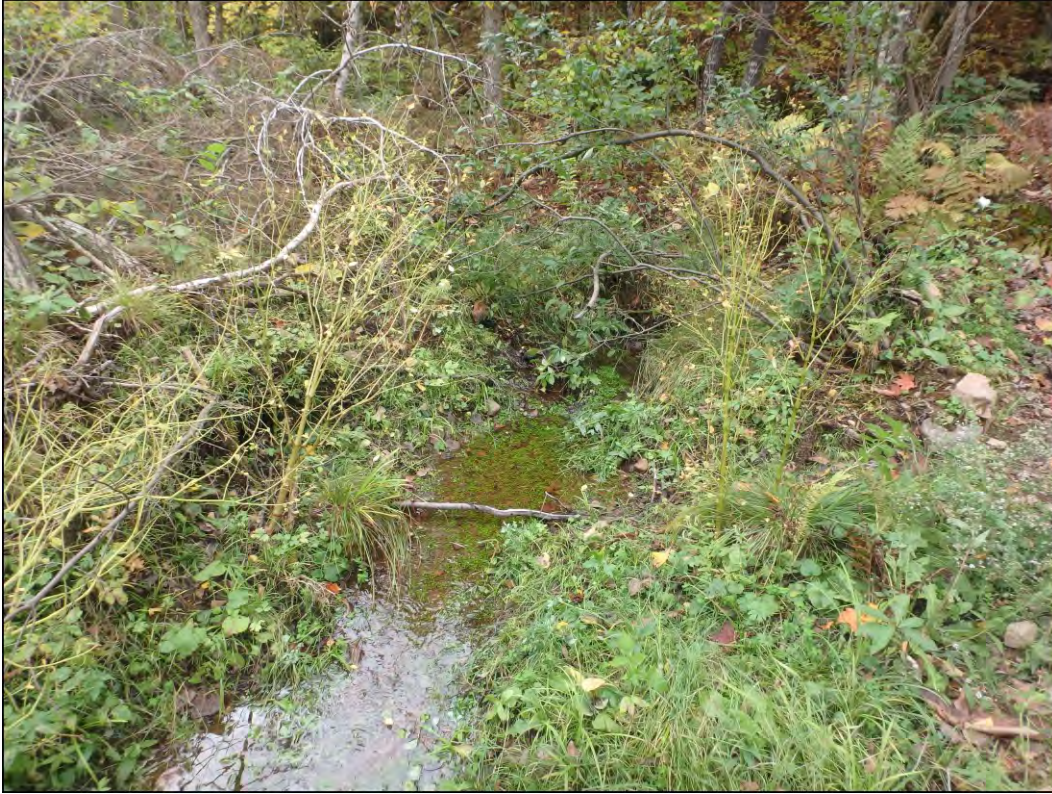
sire001i_E (downstream)

Observations			
Riparian Zone Present: <input checked="" type="checkbox"/> Yes <input type="checkbox"/> No <small>(check one)</small>			
Vegetation Layers: <input checked="" type="checkbox"/> Trees <input checked="" type="checkbox"/> Saplings/Shrubs <input checked="" type="checkbox"/> Herbs <small>(check all that apply)</small>			
Dominant Bank Vegetation (list): Fraxinus nigra, Matteuccia struthiopteris, Carex bromoides, and Calamagrostis canadensis.			
Aquatic Habitats (ex: submerged or emerged aquatic vegetation, overhanging banks/roots, leaf packs, large submerged wood, riffles, deep pools, etc.): Standing water, overhanging vegetation.			
Aquatic Organisms Observed (list): None.			
Disturbances (ex: livestock access, manure in waterbody, waste discharge pipes): Located along frequently traveled access road. Culvert under roadside.			
Observation Notes: Feature continues outside survey corridor.
